Regarding: Radon Testing
Administration Building
2455 Country Club Road
Lake Oswego, Oregon 97034
PBS Project 21600.051

RADON MONITORING REPORT

HAZARDOUS MATERIAL SURVEY PLAN

LOSD ADMINISTRATION BUILDING

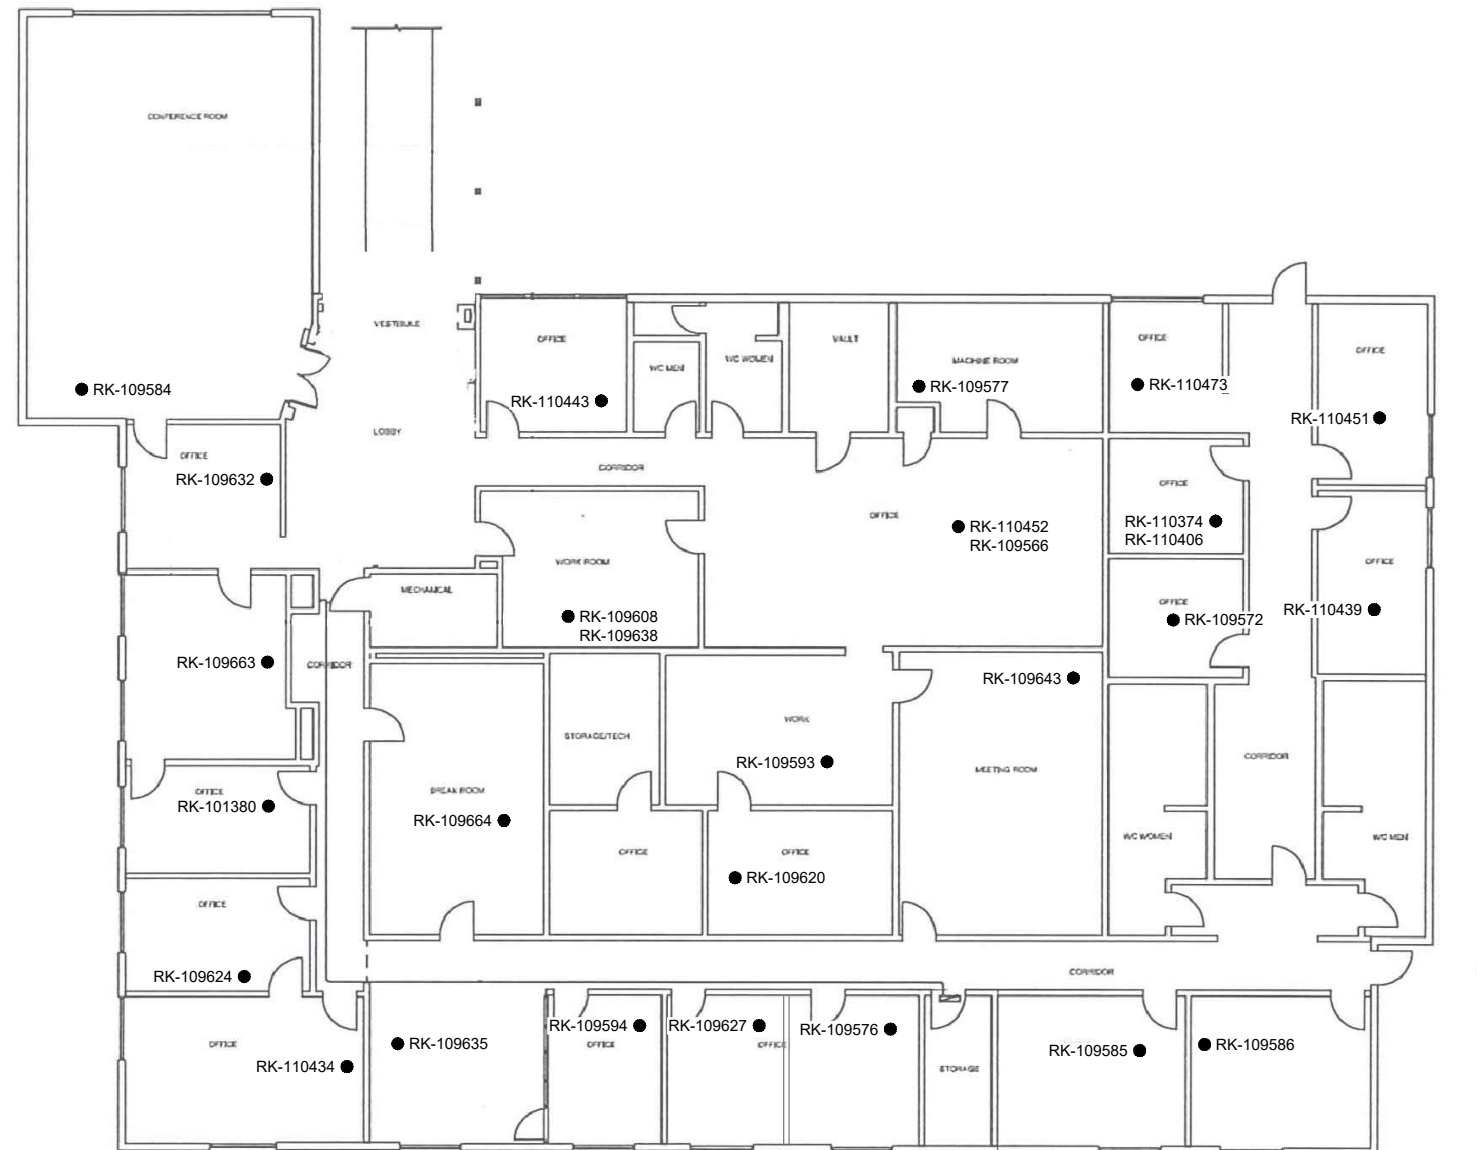
DRAWN BY JAB
CHECKED: BK
DATE: MAY 2022
PROJECT NUMBER: 21600.051
SHEET DRAWING NO:
RA7
7 of 18

1. THIS DRAWING IS DIAGRAMMATIC. IT IS FOR GENERAL INFORMATION AND SAMPLE LOCATIONS.

● RK- # RADON TEST AND KIT NUMBER
